ARL-TN-0723 • DEC 2015

# Liquid-Crystal Display (LCD) Screen Thermal Testing to Simulate Solar Gain

***Computational and Information Sciences Directorate, ARL***

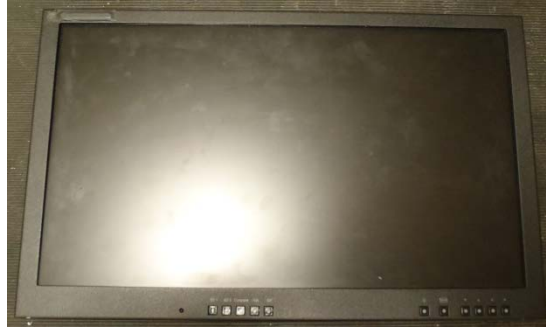
**Fig. 1 Front view of the View Port 20 inch HD/SD DayBrite Monitor**

The View Port 20 inch HD/SD DayBrite Monitor (Model Number DHD 20W DB) features metal chassis measuring 19 inches x 11.63 inches x 2.25 inches. The chassis includes a 20 inch screen with a user adjustable 4:3 or 16:9 aspect ratio. The chassis is also equipped with 2 exhaust fans used to circulate and exhaust air from the chassis. The DayBrite Monitor features SDI, Composite, VGA, and DVI inputs to accommodate various configurations. Figures 1 and 2 show the front and rear views of the monitor.
